# **A Brief History of the Great Clock at Westminster Palace**

**Its Concept, Construction, the Great Accident and Recent Refurbishment**

**Mark R. Frank**

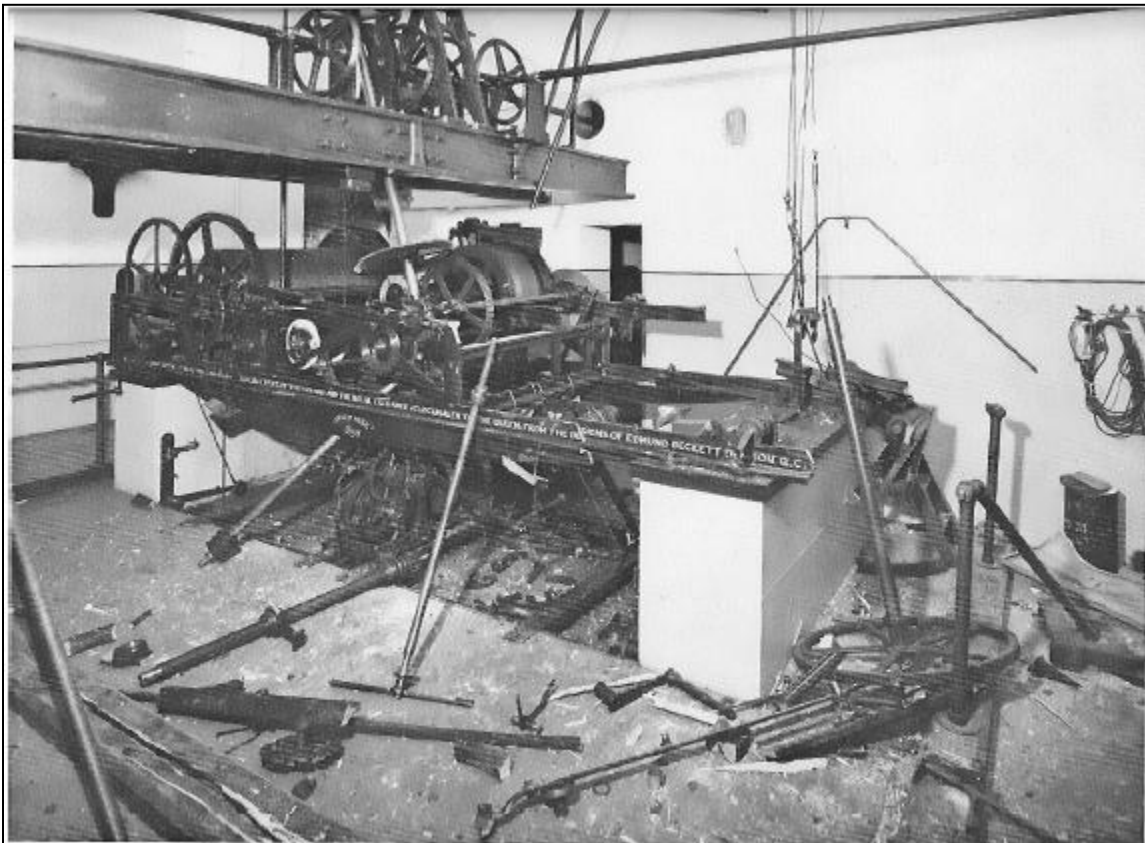
Photo 1. Chime train and frame stripped away. Count wheel attached to its frame and laying in the foreground.

*Notice in the first post event photo, prior page, the section of the top frame rail with the quarter count wheel (known as a locking plate in England) still attached laying in the foreground. The lower main frame front member with the dedication inscription is broken about one-third of the way from the right end of the damaged chime area. The main frame was broken in five places. At the top, middle portion of the photo one can just see the fly fan drive tube hanging next to the motion works lead off support girder. In the photo above, this is more apparent as the fly itself is partially supported by the remaining fly steady which is attached to the upper girder with the balance of the fly entangled on the lead off wheel nest. The next page shows two other angles of the movement as well as views of where the chime barrel came to rest.*

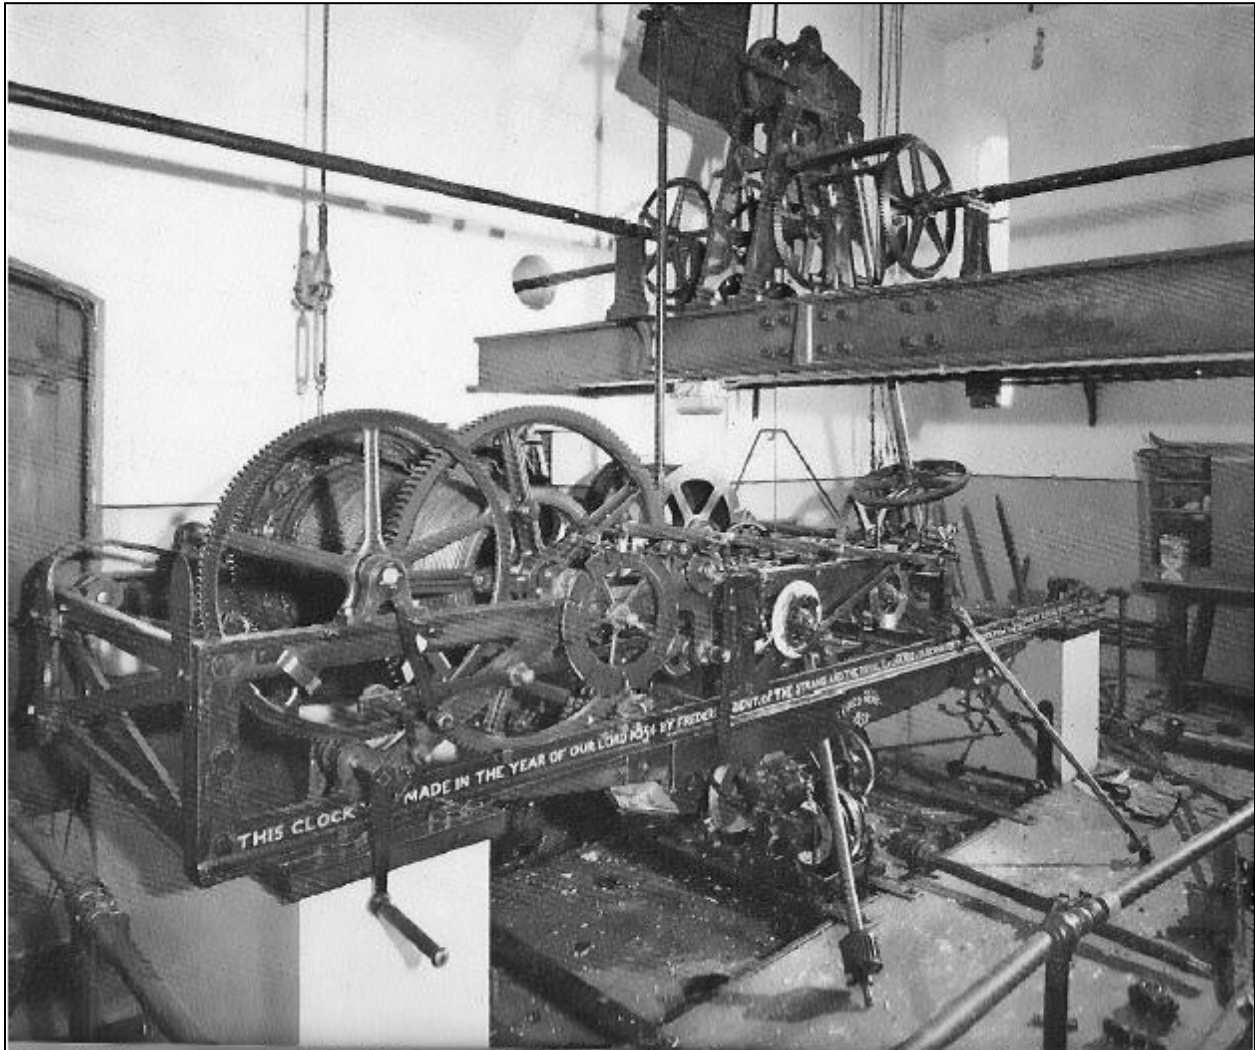
**Photo 2. Three-quarter view left side. Damaged fly is left hanging on its steady; entangled on the lead-off wheel nest.**

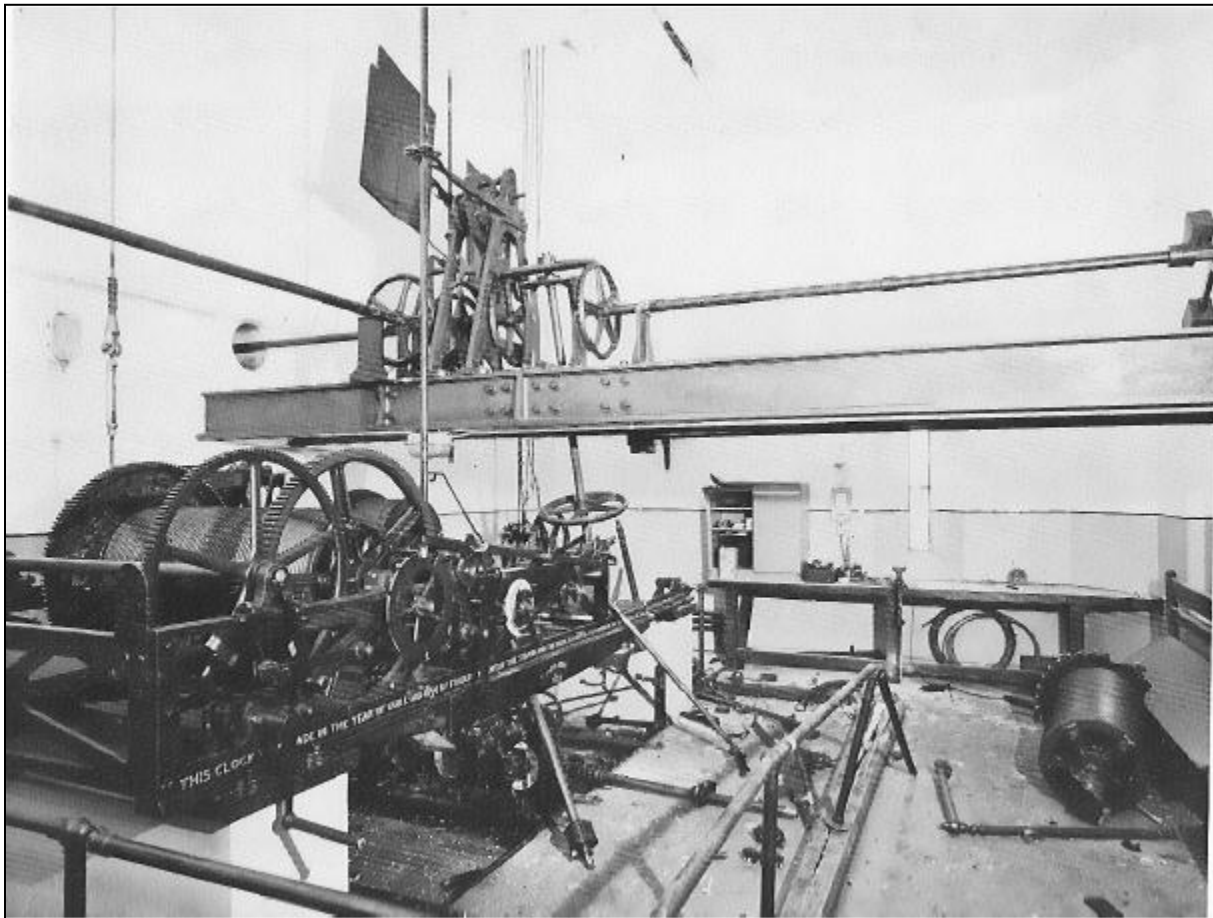
Photo 3. Strike side view and showing where 1/4 ton chime barrel came to rest.

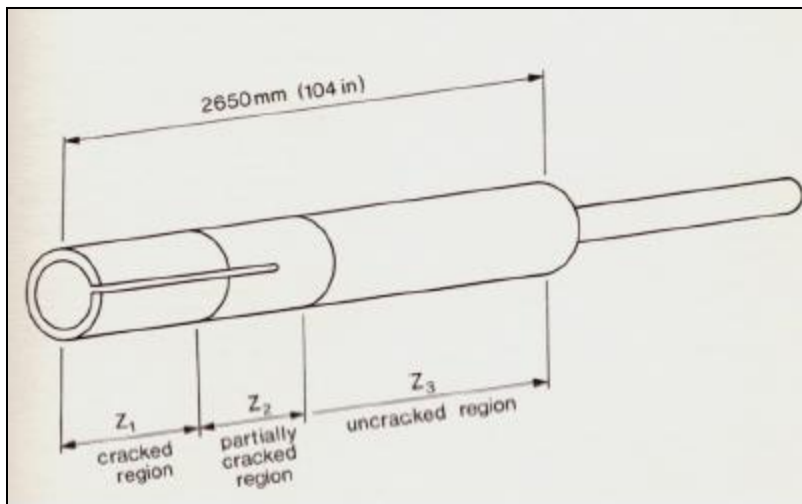
Fig. 1. Tube schematic showing main fracture.

A crack had initiated, probably in the lower end of the tube, which developed into a fatigue crack. This propagated for 1 m (40 in) along the tube, at which stage transverse cracks developed; these extended halfway around the circumference of the tube before secondary helical and longitudinal fractures developed during the final stages of the tube failure.

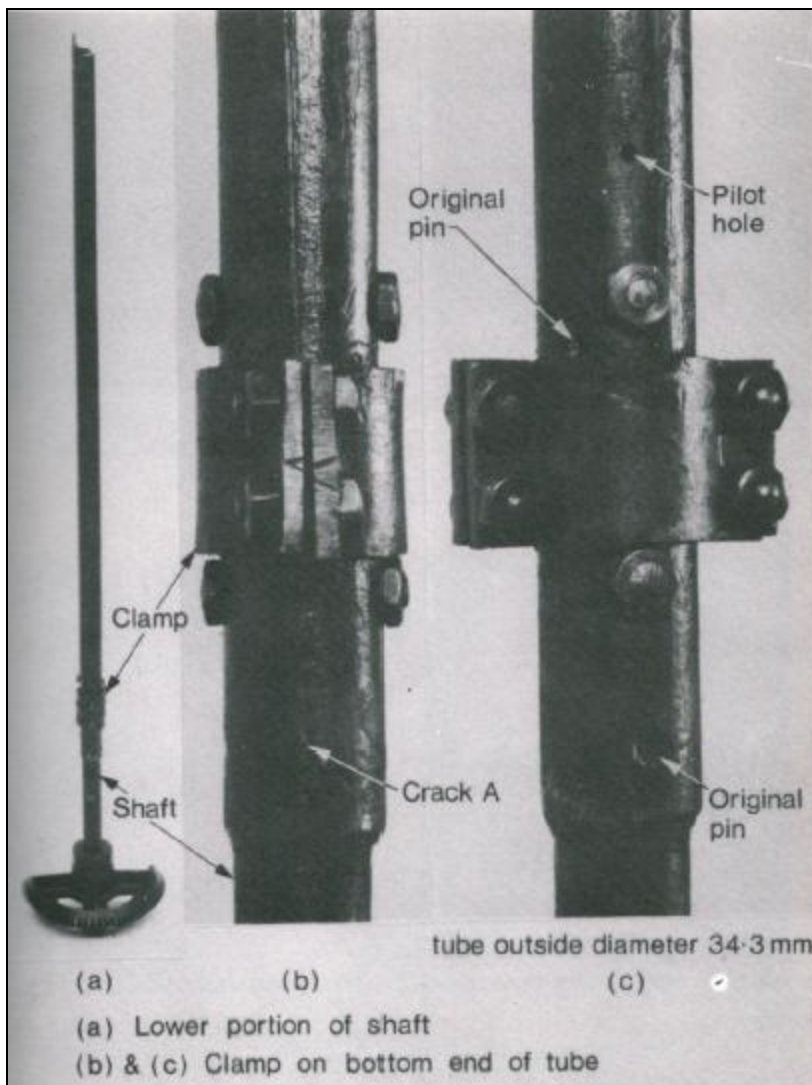
Fig. 2. Chime drive shaft with damaged bevel drive wheel.

**Lower half of the broken tube and its bevel, (Fig 2).**

*The pipe clamp was installed in the 1956 overhaul to keep the bevel wheel arbor from slipping within the tube. The fly governor is a critical part of the chiming mechanism since the fly acts as an air brake to control the rate of chiming, and hence the speed of the mechanism. There was extensive fatigue cracking in the wrought iron tube component of the vertical shaft. The main fatigue crack (a), which followed weld seam along the length of the tube, extended approximately 40 inches from the lower end of the tube where it was attached to its driving bevel gear wheel. Because it was masked by the welded seam, and because the outside of the tube was a dark grey color covered in parts with a black oxide scale, the crack was not easily discernable, apart from the first few inches at the lower end, marked 'Crack A'.*

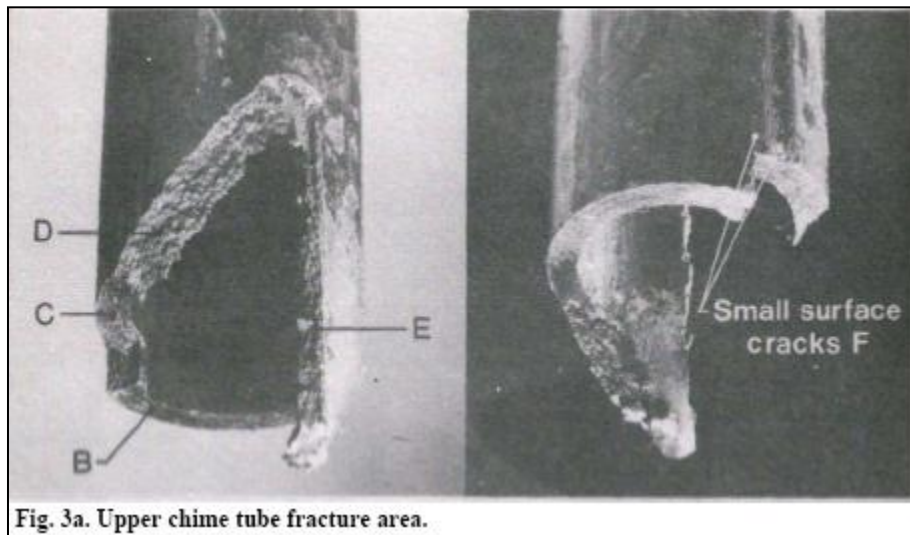
**Broken ends of the chime tube, upper portion, (Fig 3a) and lower, (Fig 3b).**

Circumferential fatigue cracks had developed near the leading end of the longitudinal crack marked A, and the two which lead to the failure of the fly shaft are marked B and C. These cracks which were initially approximately perpendicular to the axis of the tube, changed to a helical mode with that at D running 45° to the tube axis. The region of final failure was manifest by its brighter appearance and its rough and deformed surface, marked at E. Tube outside diameter is 34.3 mm (1 3/4 inches).

Fig. 3a. Upper chime tube fracture area.

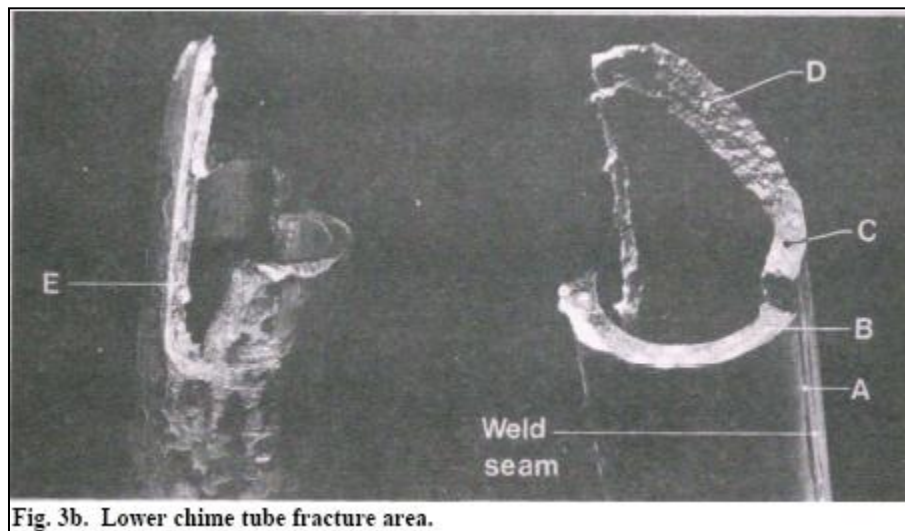
Fig. 3b. Lower chime tube fracture area.

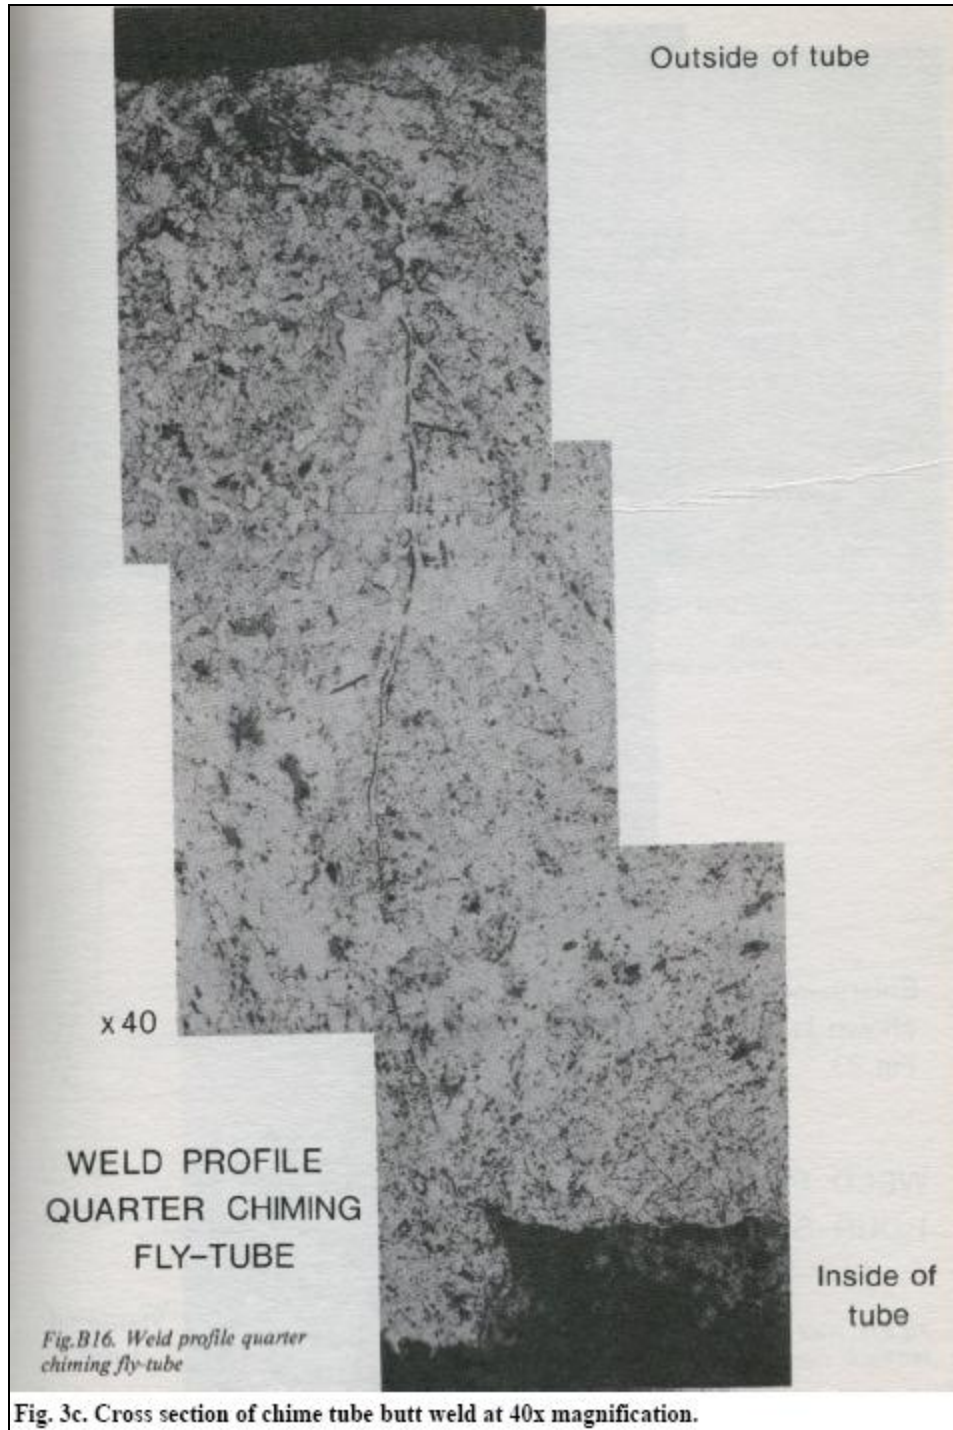
**Weld Profile of Quarter chiming fly tube at 40x magnification, (Fig 3c).** A macrograph of the weld region in the upper portion of the tube 100mm ( 4 inches) above the circumferential crack marked C (*Fig 3a*) is shown below, from which the fibrous and laminar nature of the material is apparent. The flow lines indicate that a form of butt weld was made, and a bulge marking the junction where the two ends of the joint were forced together is evident, especially on the inside of the tube. The area shows the presence of a stress raising notch at the inner surface of the tube.

This was filled with slag and was probably formed during the welding process when the surface material on one side of the joint was forced to flow past that on the other side. The root of the notch lay along the line of the weld, which can be clearly seen in *Fig. 3c*. The weld line was marked by a region of differing etching characteristics, probably caused by higher concentrations of oxygen and other impurities at the weld. The weld joint coincided with a plane of maximum shear stress, and as seen in the photo above, the crack followed the line of the weld across the tube wall, joining the notch at the inner surface to a similar notch (though less evident) at the outer surface of the tube.

*So examination of the chime fly tube shows that the way the tube was manufactured, using a butt welded seam, and to a lesser extent some manufacturing and materials quality control issues, directly contributed to the failure. It was an unfortunate coincidence that the maximum sheer stress for the butt weld would be present along its weakest, which is longitudinal, profile. To be fair, this was before the advent of seamless tube manufacture. In addition this type of tubing was generally used in water and gas piping which would not present the types of shear stresses to the butt weld seam. In this application the tube was called upon to perform structural duties for which it was not suited. The presence of the weld seam, through which the crack had progressed masked the crack which may have, in the absence of such camouflage been discovered prior to the accident.*

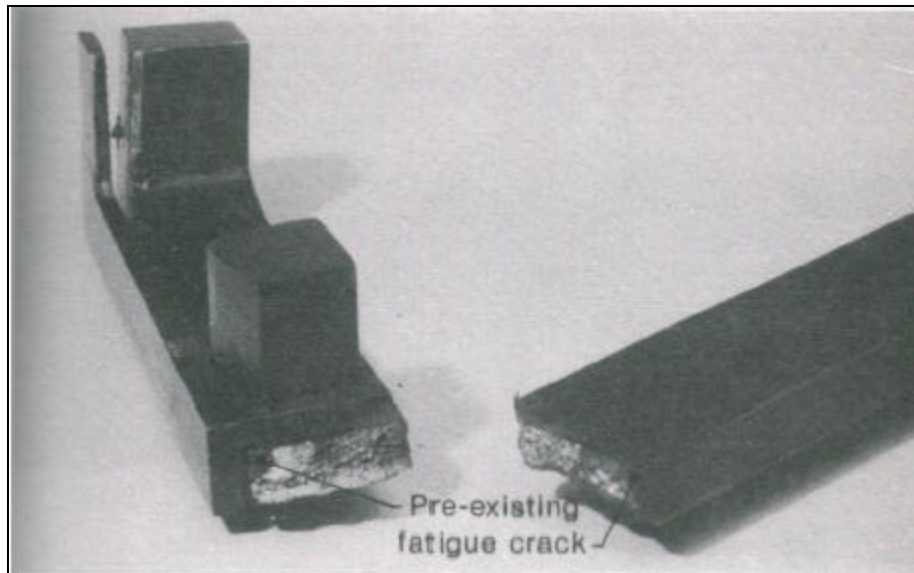
The head of the wrought iron locking lever was broken off. The main fracture appeared to be caused by impact but the fractured faces contained a zone of fatigue damage which no doubt existed prior to the final failure, (Fig 4a). The tail of the locking lever was bent and damaged locally from impact, and its drive shaft bent at the lever end, (Fig 4b).

**Fig. 4a. Chime locking lever, fractured end piece.**

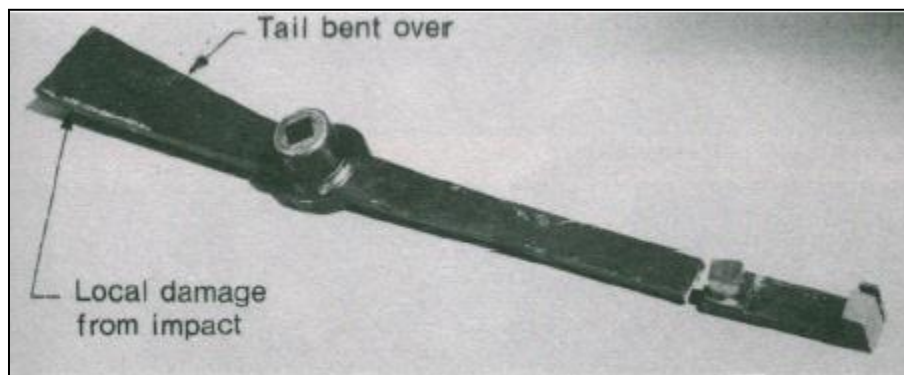
**Fig. 4b. Chime locking lever, overall view showing bent counter-balance tail.**

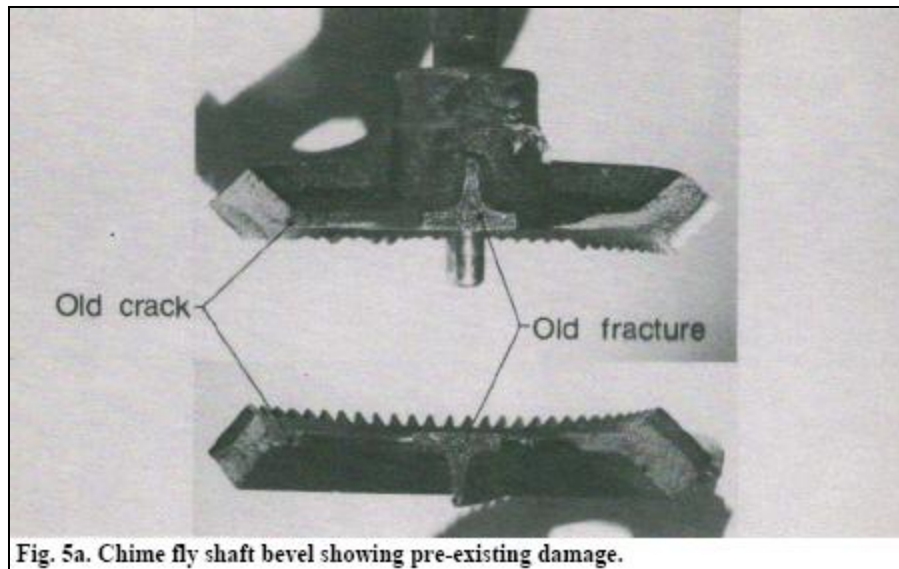
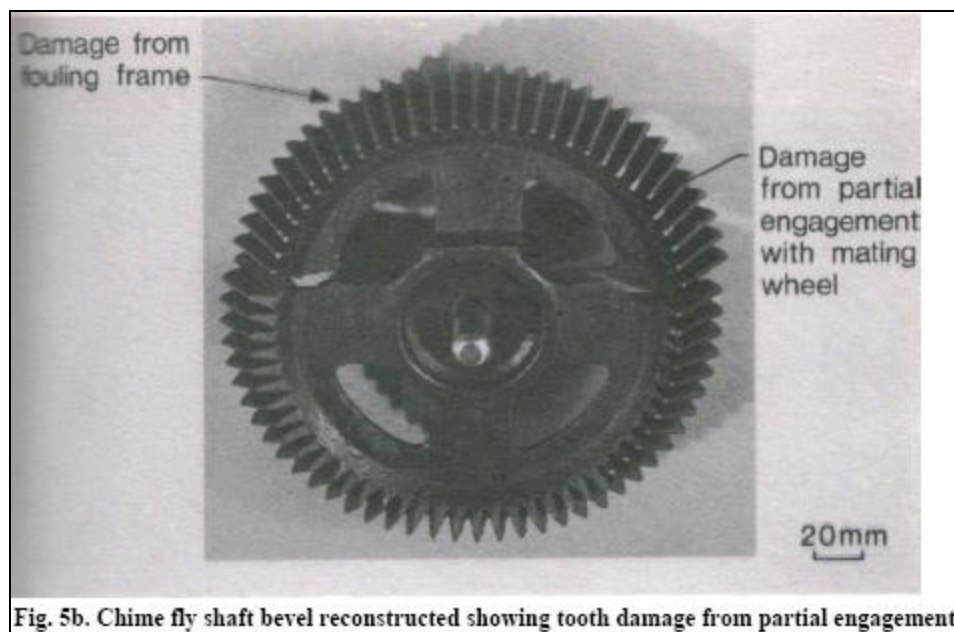
There was an old fracture in one of the four spokes of the cast iron bevel wheel on the fly shaft, (*Fig 5a*) and one other spoke also contained an old crack. The teeth on the fly shaft bevel were damaged consistent with that expected from the mating gear wheel on the drive shaft if it were partially engaged, (*Fig 5b*).

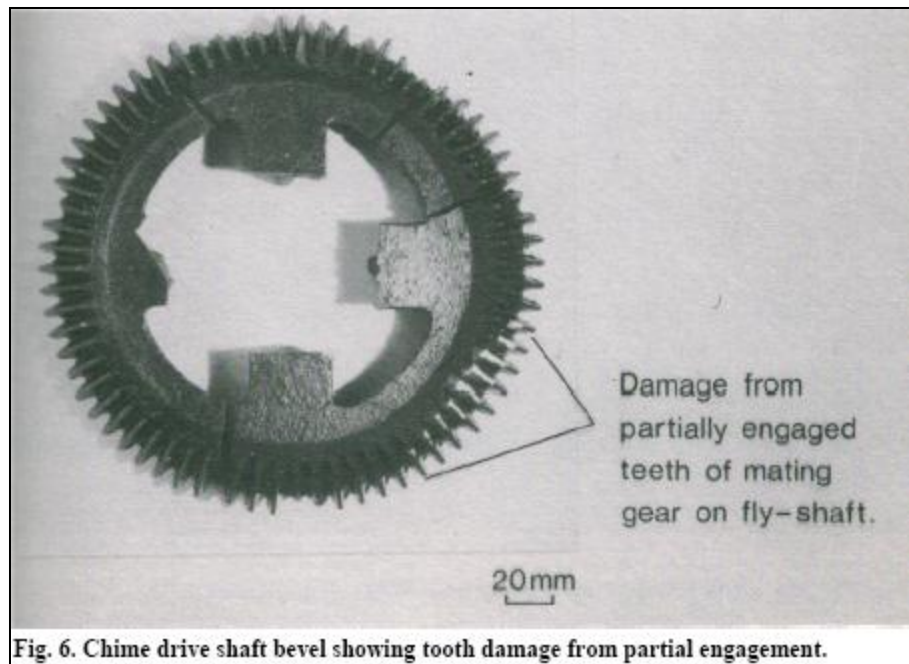
**Chime drive shaft bevel, (Fig. 6).**

The damage to several of the drive shaft bevel wheel teeth was consistent with that expected from the mating gear wheel on the fly shaft if it were partially engaged, (Fig 6).

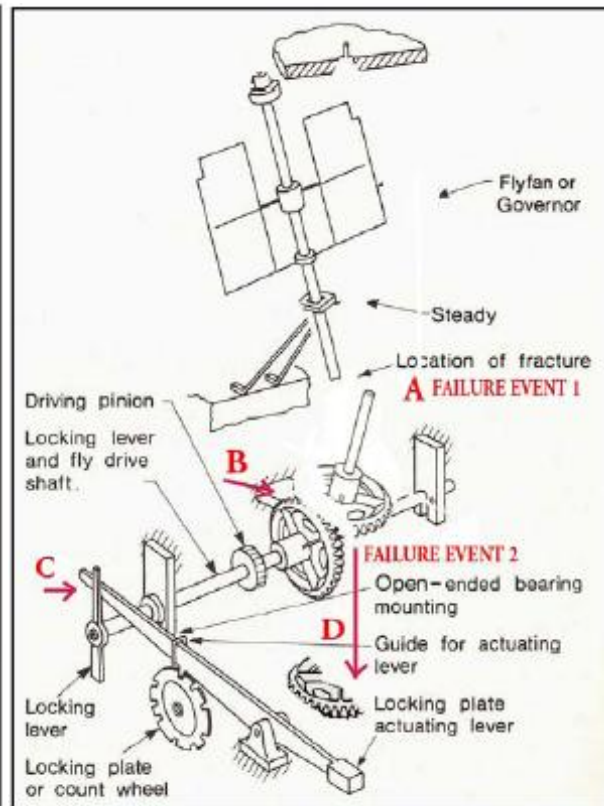
Fig. 8. Fly governor mechanism after 3:30 AM chime

(Fig. 8). The observed crack in the welded seam of the tube element of the fly shaft probably originated at its lower end, *marked 'A'*, where it fitted onto the shaft which carried the bevel wheel used to transmit the drive through the tube. Slow propagation of this crack, within the welded seam along the length of the tube, may have taken place during a substantial portion of the life of the clock. *As noted earlier, this fatigue crack resulted in the failure of the fly shaft.*

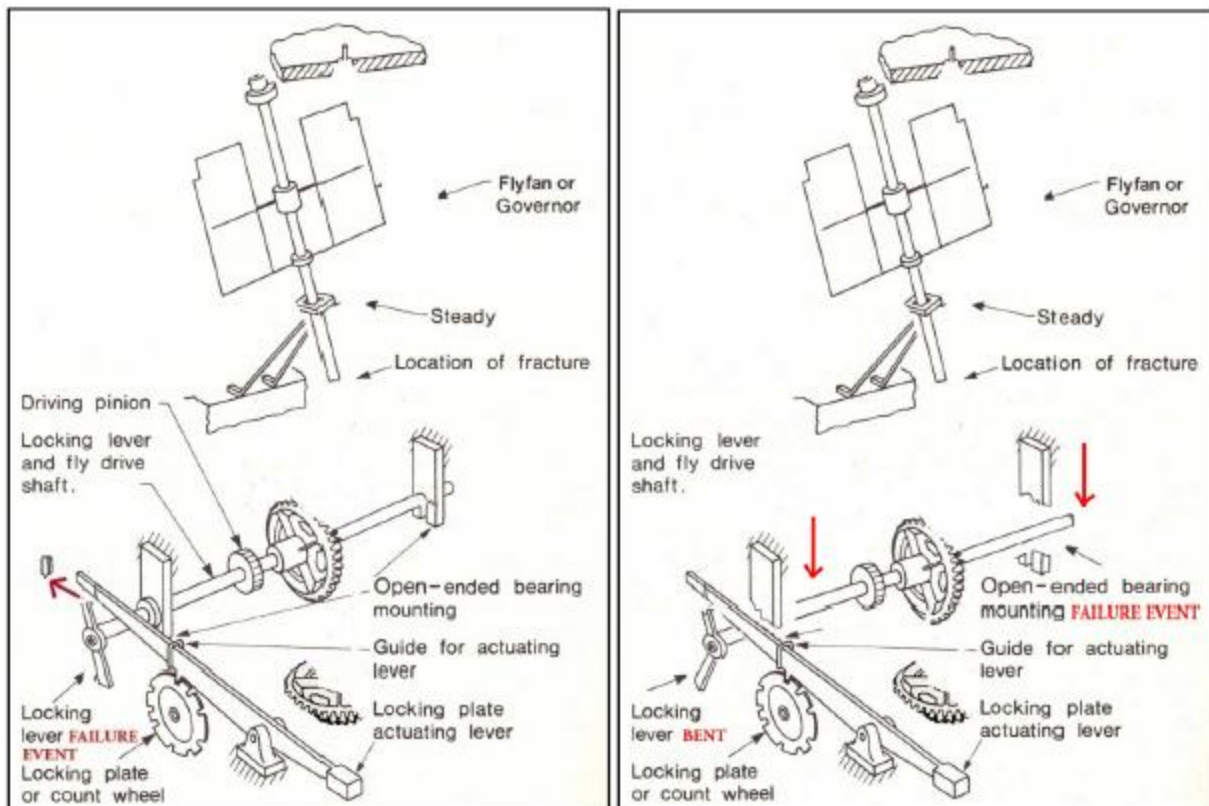
With the bevel wheels disengaged and without the restraint of the fly governor, the drive shaft when next released at 3:45 AM, would have been able to increase its speed of rotation. When the locking plate actuating lever attempted to stop it, the locking lever could have struck it with sufficient force to break off the end of the locking lever, particularly since it already contained a fairly sharp mechanical groove from which a fatigue crack, (Fig. 4a), had emanated, (Fig. 9).

Without the locking and governor mechanism the drive shaft would have continued to rotate at an increasing rate (*reaching an estimated 1600 RPM*<sup>17</sup>); it was designed to operate at less than 100 RPM, and this conceivably was when the jamming of the locking lever tail and the failure of the drive shafts open ended bearings occurred, (Fig. 10). The locking plate actuating lever and locking plate assembly broke away as a unit with part of the frame still attached, (Fig. 11), and this presumably is when the guide for the actuating lever fractured from an old crack.

Fig. 9. Governor mechanism post 3:45 AM strike, event 1. Fig. 10. Governor mechanism post 3:45 AM chime, event 2

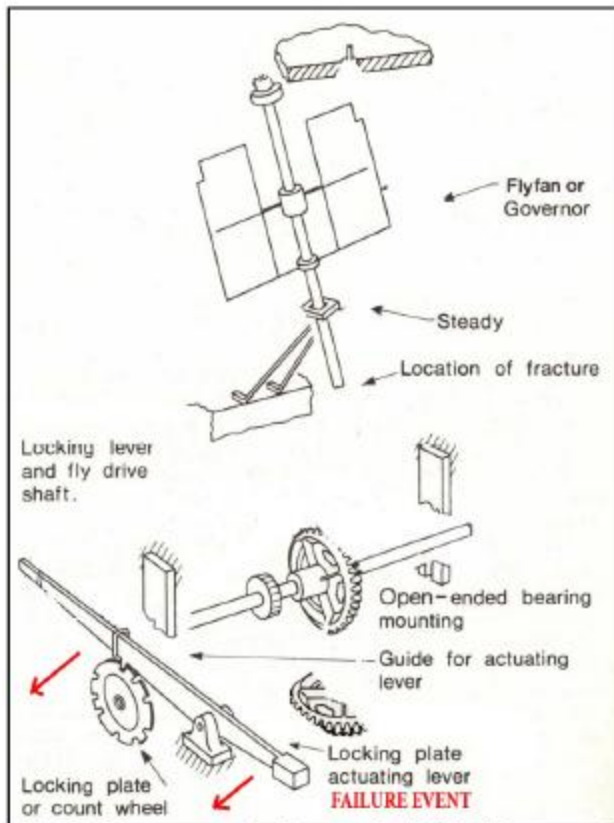
With the fly governor and locking constraint removed completely the release of potential energy from the driving weight at 12.5 kN at 40 m (1 ¼ ton/f at 132 ft)\*<sup>1</sup> forced the mechanism to operate at speeds in excess of design limits. The single pulley arrangement used on the driving weight would result in the cable unwinding from its drum at twice the velocity of the falling weight. These excessive operational speeds would be expected to lead to parts of the clock mechanism breaking loose and to breakup of the cast iron frame. Early in this train of events the jamming of the quarter bell striking levers on their operating cams, which were designed to operate slowly, would be expected to have imposed sever dynamic impact loading on the frame and mechanism until some of the levers and cams broke, and this section of the frame broke away.

Fig. 11. Governor mechanism post 3:45 AM chime, event 3

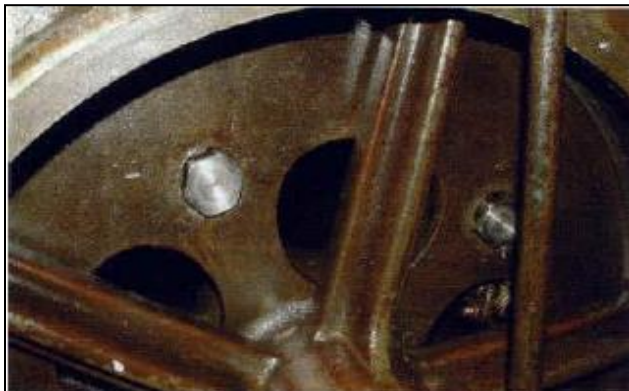
1. Rear view of hour strike barrel. Bolt heads were rubbing.

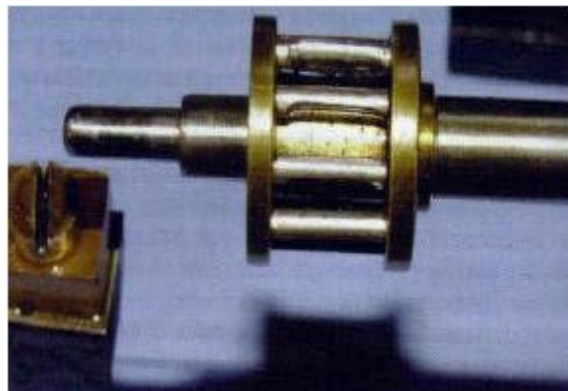
2. Escape wheel pinion, showing wear on trundles.

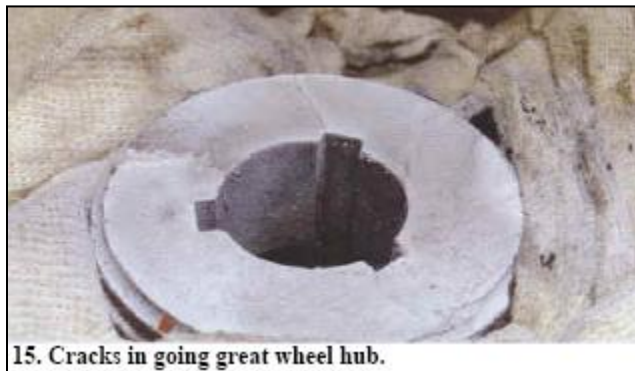
An inspection of the going barrel's arbor keyed collet revealed more of the dreaded stress cracks. These were mated to tapered keys that were on the arbor and originally hammered into place to secure the assembly, **Photo 15**. The crack was repaired with a method called 'cold stitching', a technique used to repair castings. A series of holes is drilled using a custom jig, the series of holes being at right angles to the crack, **Photo 16**. A specially shaped lock insert is put into the hole and secured with a resin. The lock is made from a high nickel steel alloy and is much stronger than the surrounding cast iron.

15. Cracks in going great wheel hub.
