# **A Brief History of the Great Clock at Westminster Palace**

**Its Concept, Construction, the Great Accident and Recent Refurbishment**

**Mark R. Frank**

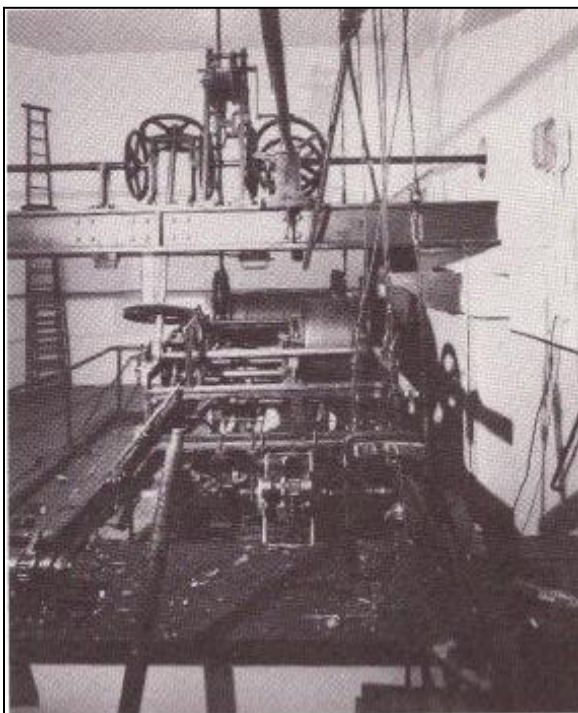
Photo 4. End view from chime side

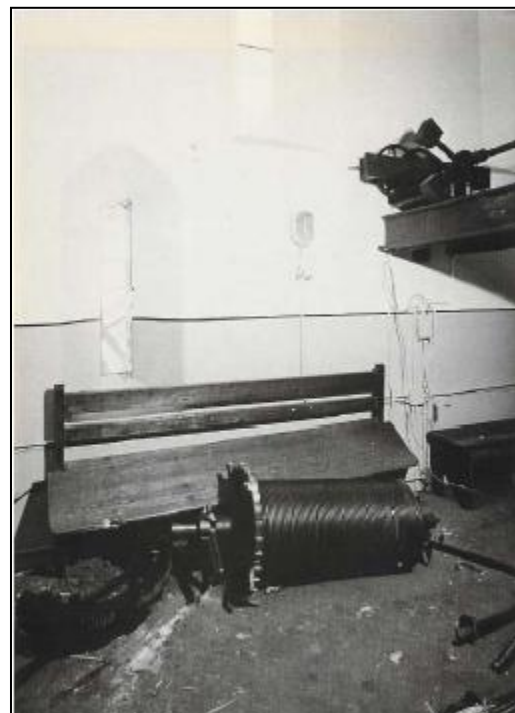
Photo 5. Note chime main wheel to the left

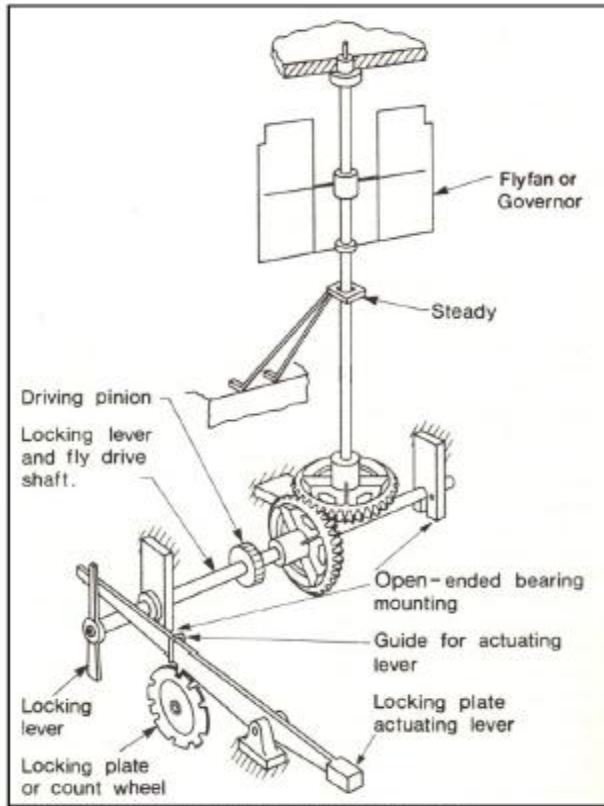
Fig. 7. Fly governor mechanism pre-damage.

(Fig. 8). The observed crack in the welded seam of the tube element of the fly shaft probably originated at its lower end, *marked 'A'*, where it fitted onto the shaft which carried the bevel wheel used to transmit the drive through the tube. Slow propagation of this crack, within the welded seam along the length of the tube, may have taken place during a substantial portion of the life of the clock. *As noted earlier, this fatigue crack resulted in the failure of the fly shaft.*

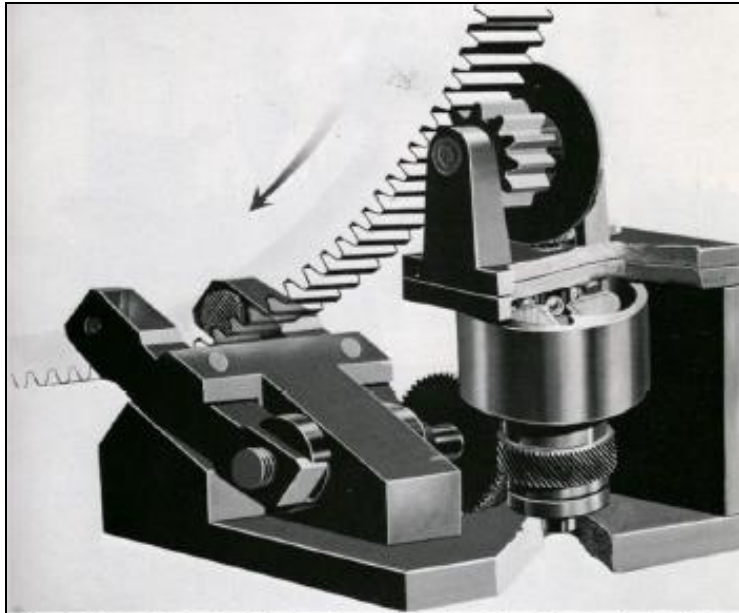
Fig. 12. Inertial safety brake installed on both strike main wheels.

tubes were also replaced with tubes made of modern high strength material. To insure that such an accident could never happen again, Britain's National Physics Laboratory designed a unique brake system, (Fig. 12), prior page, that will cause the great wheel to be stopped if it senses that the wheel is turning more than twice its normal speed. One was installed on each strike train.

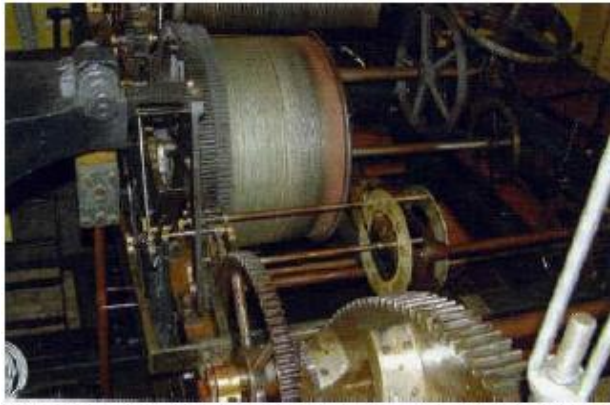
3. Movement view. Note replaced bronze strike wheel and cams.

In **Photo 3**, notice in the lower right the portion of the quarter strike train that was replaced after the accident in 1976. It was remanufactured in bronze to avoid the types of fractures that plagued the original cast iron material. Ian Westworth, Paul Robertson and Huw Smith are the three Palace clockmakers, **Photo 4**. Apart from making three visits a week up the tower to the clock for maintenance and winding, they are responsible for winding, servicing and repair of the over 1000 clocks in the palace as well. Some of you with large clock collections thought you had a lot of winding and repair work! Six to eight weeks were allocated for the work. Since it was decided to keep the hands telling time, an early task was to specify a synchronous drive unit that would neatly fit next to the bevel wheel cluster. A special unit was commissioned, **Photo 5**, built and tested at full load.

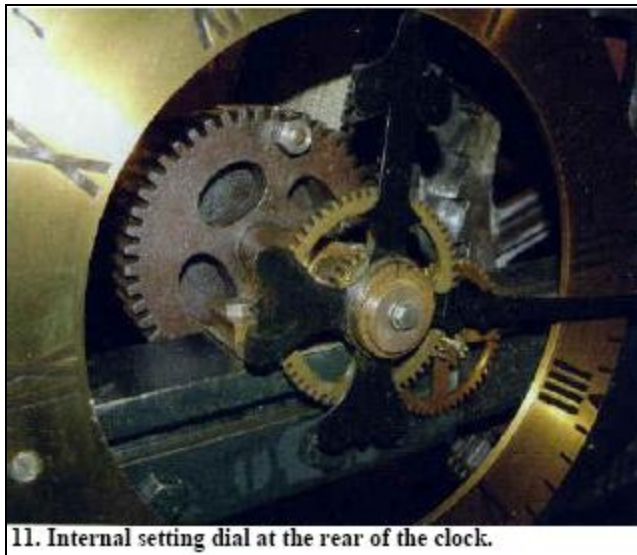
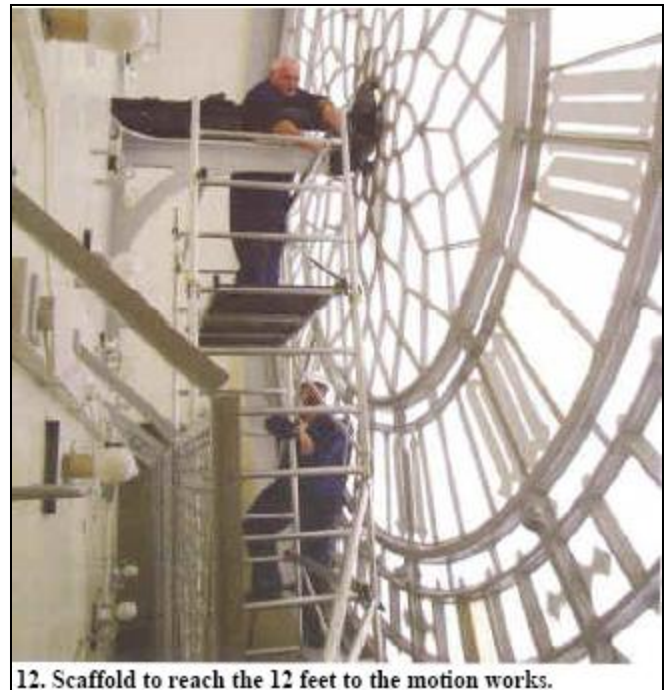
Since the hour tube is about 12 feet from the floor, scaffolding was installed to reach the behind-the-dial components, **Photo 12**. The tubes reaching the hands are supported by roller wheels. There are two sets of these for each dial for the hour and minute arbors. In the past some of these rollers had seized up leading to flats on the surfaces of some of these rollers. This is an indication of the sheer power that is delivered by the movement, **Photos 13 and 14**.

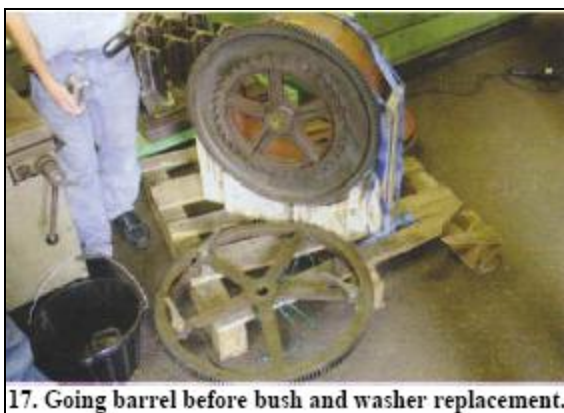
All bushes were replaced with new bronze, and it was decided to make a new arbor. The going barrel needed new bronze bushes, **Photo 17**. The old thrust washer had worn thin which lead to the end bolts mounted on the barrel to rub on the great wheel arms when being wound, and was replaced. With the flat bed frame stripped of most parts, **Photo 18**, the frame members were inspected and other parts were inspected and cleaned.

17. Going barrel before bush and washer replacement.

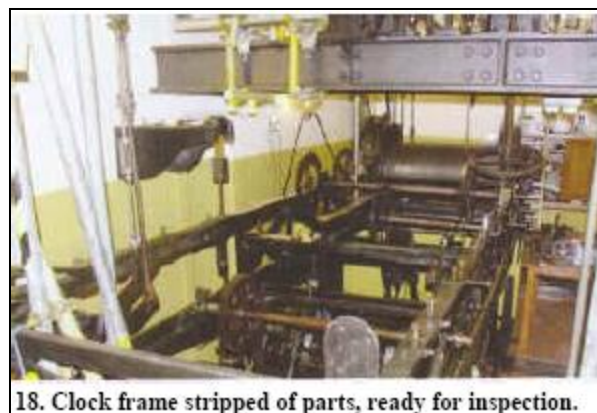
18. Clock frame stripped of parts, ready for inspection.
